# VIVABLAST SOLUTIONS (1/4)

## ALUMINUM FSIV TANK LINING

- Client: South East Asia Shipyard
- Object: Potable tank in aluminum Fast Service Intervention Vessel
- Scope of work: Tank lining & Pitting corrosion repair
- Conditions: The tank is filled with brackish water (less than half tank) for 2 week Sail Trail then left it empty for several months. It results in 20~30% pitting corrosion at the bottom and aluminum salt was occurred.

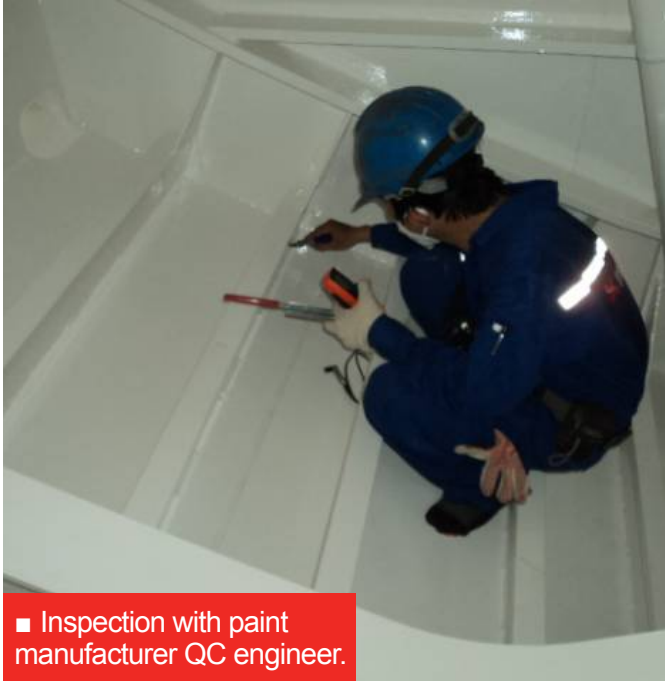
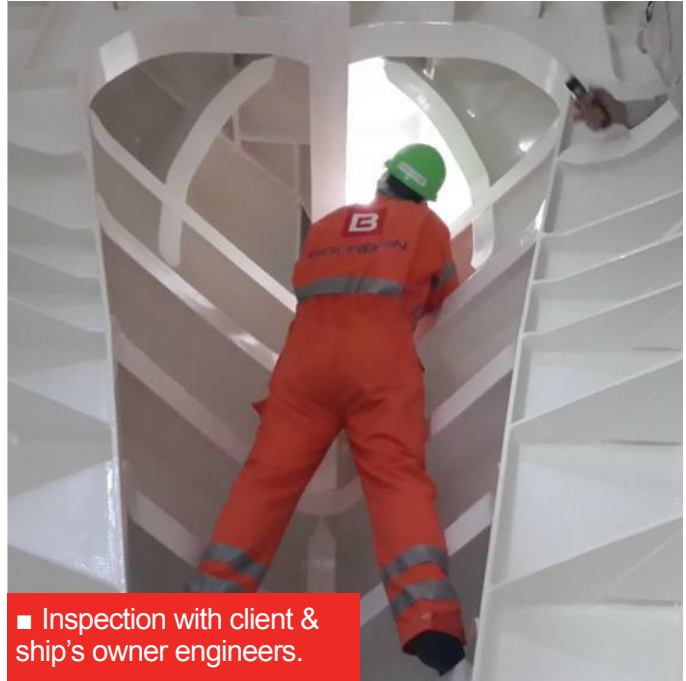
■ Inspection with paint manufacturer QC engineer.

■ Inspection with client & ship's owner engineers.

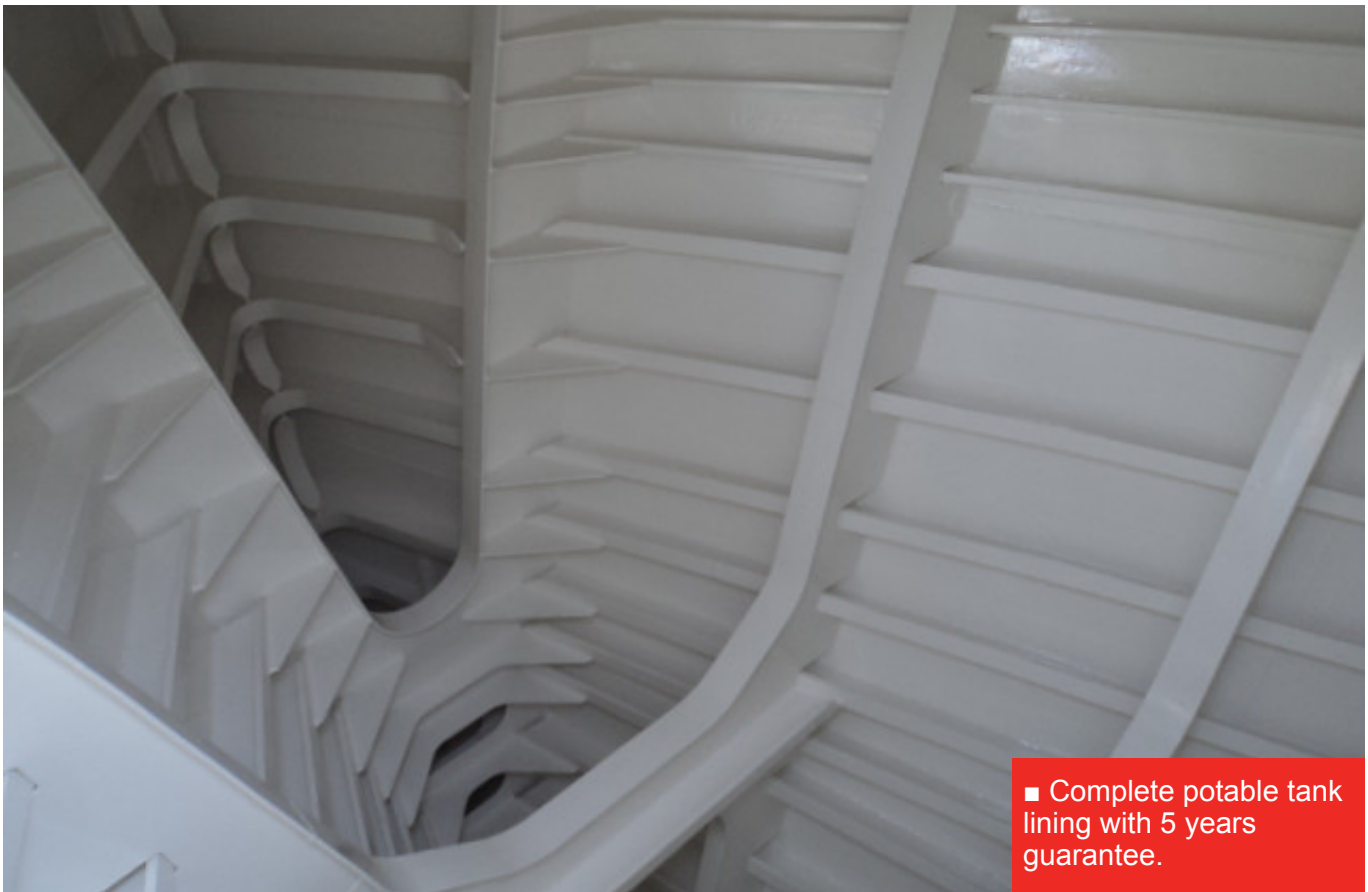
■ Complete potable tank lining with 5 years guarantee.
