# VIVABLAST CASE STUDY (1/3)

## BALLAST TANK COATING

- Customer: SEAS
- Ballast Tank Coating
- Location: X51 Shipyard
- Start in March 2009

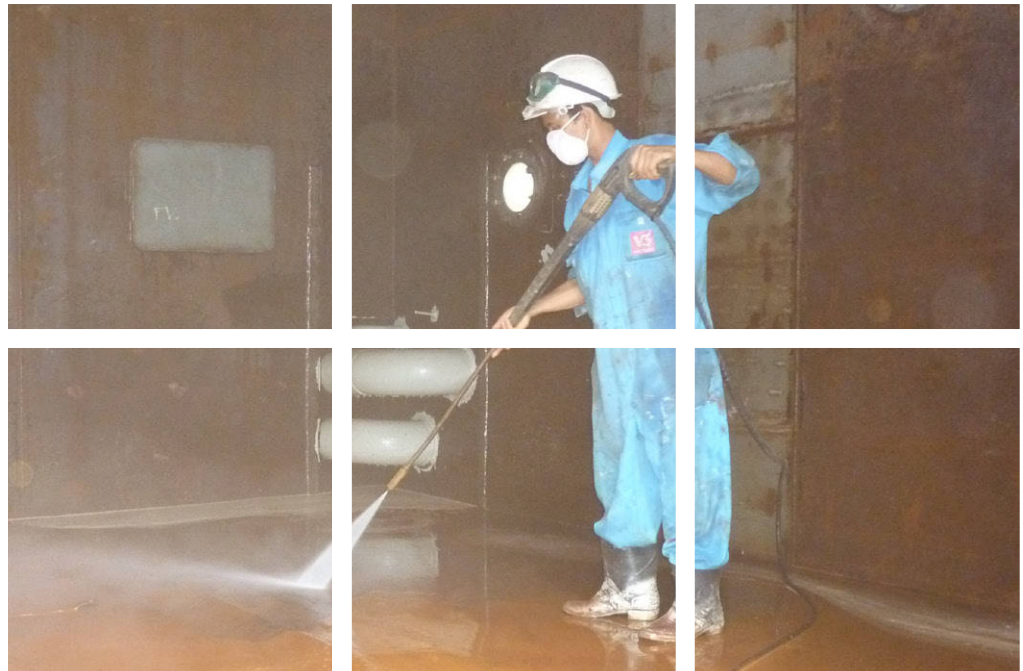
### ■ STEP 1

- HP water washing (min 200 bars) to remove dirt, dust and grease

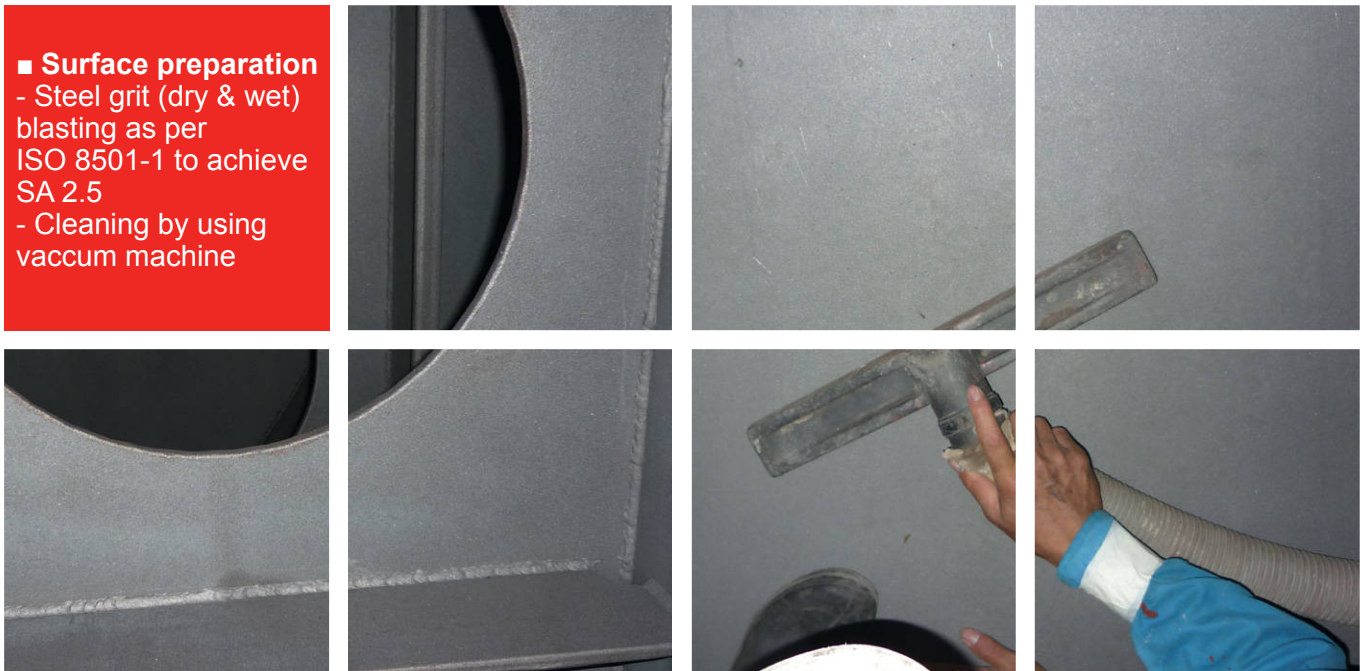
### ■ STEP 2

- Surface preparation
  - Steel grit (dry & wet) blasting as per ISO 8501-1 to achieve SA 2.5
  - Cleaning by using vacuum machine

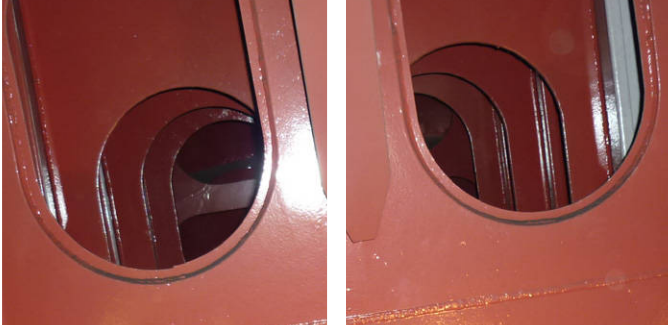
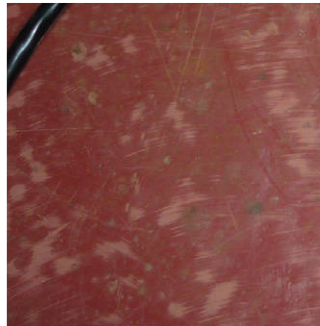
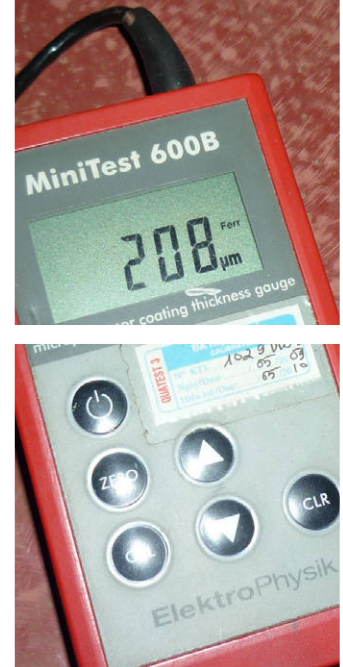
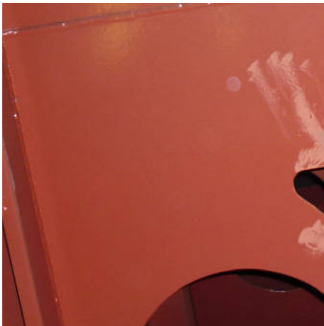
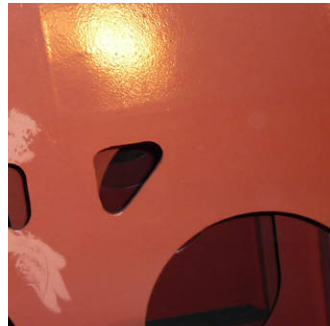
### STEP 3

- Application of polyamine cured epoxy paint (multi strength) primer coat (wet & dry) to achieve DFT 200 $\mu$  (red color)

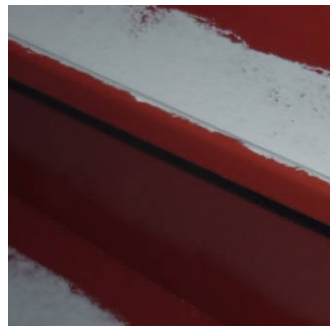
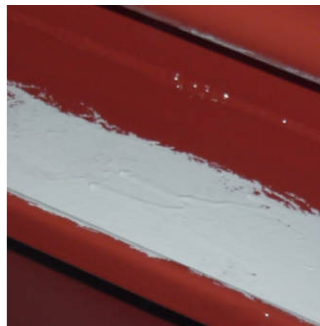
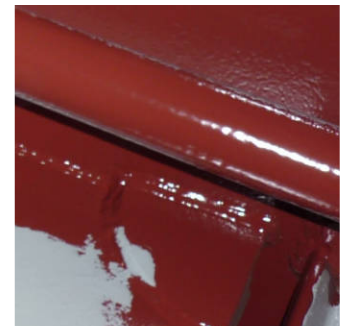
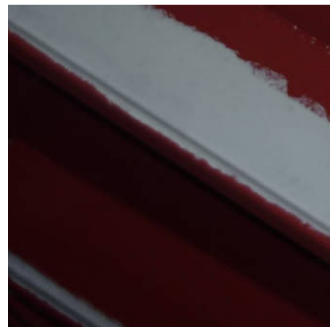
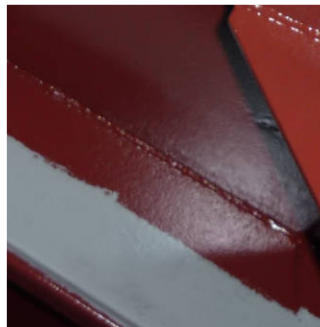
### STEP 4

- Application of polyamine cured epoxy paint topcoat (strip coat) (wet & dry) to achieve DFT 200 $\mu$  (grey color)

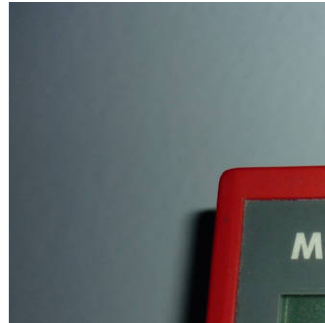
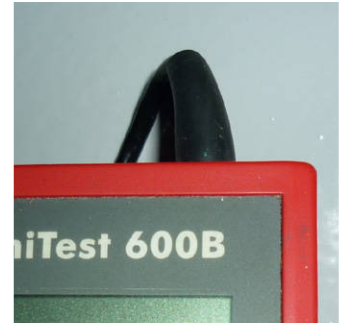
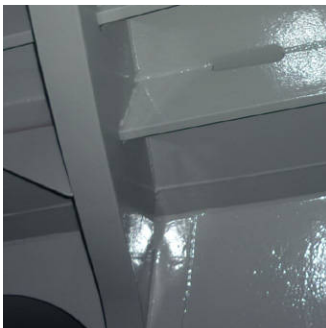
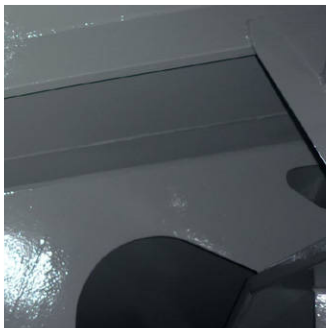
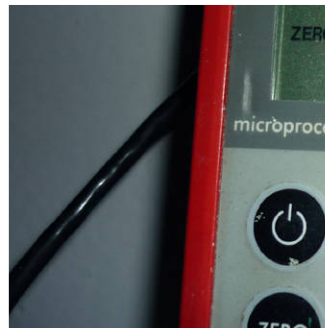
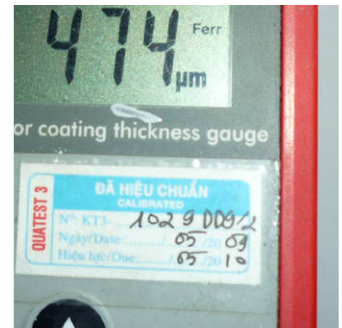
■ Application of polyamine cured epoxy paint top coat (full coat) (wet & dry) to achieve DFT 200 $\mu$  (grey color)
