**POWER GENERATION:
MAINTENANCE SHUTDOWN**

**MANUFACTURING :
CHUTE & DUCT FABRICATION FOR GLASS RECYCLING PLANT**

**RENEWABLE ENERGY:
WIND BLADE INSPECTION AND REPAIR WORKS**

**OIL & GAS:
PFP APPLICATION**

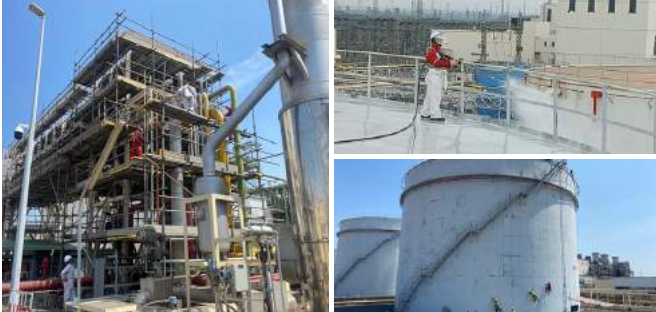
With a proven track record in power generation, VIVABLAST recently executed innovative anti-corrosion coating by employing competent access solutions at a major thermal power plant. Our team of multi-skilled technicians swiftly switched between rope access and scaffolding techniques to effectively access difficult-to-reach areas, such as pipe racks, boiler castings, oil storage tanks, and other structures, enabling them to plan, execute tasks efficiently with the utmost safety and on schedule.

VIVABLAST places the utmost importance on quality, that's why we strictly followed a well-defined procedure, from surface preparation to the application of corrosion-resistant coating. The coating used was Zinga, an advanced film galvanizing system from Belgium, containing 96% zinc and free from toxic elements, which provides effective corrosion protection for a wide range of surfaces. The entire process was well-controlled to ensure the highest quality standards by our experienced Quality Control team. We are grateful to our client for their trust and collaboration, which contributed to the successful completion of the project on time and within budget. ■

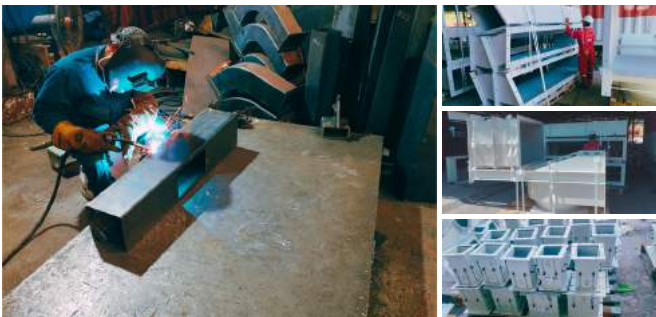
VIVABLAST is a leading company well-known for offering comprehensive solutions for steel structure fabrication - from material supply to final delivery. We were successfully awarded the chute and ductwork manufacturing project for a client in Austria. Our fully equipped fabrication workshop allows us to deliver complete steel fabrication projects - from in-house construction to delivery at the client's location.

VIVABLAST's highly skilled team thoroughly executed the entire project, precisely cutting and bending sheet metal to desired shapes, followed by expert welding, blasting, and painting for anti-corrosion protection. Utilizing diverse specialized equipment, we met all client specifications and deadlines, upholding our commitment to industry-leading quality standards (ISO, AISC, ASME). The project was a complete success and we are thankful to receive the client's trust. ■

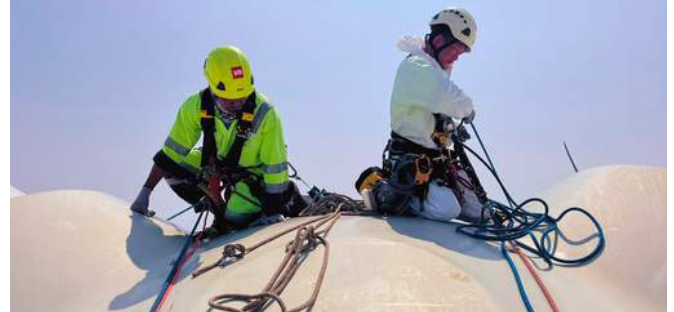
This month, we performed comprehensive inspections of wind turbine blades at nearshore wind farms in Vietnam, including both the interior and exterior surfaces. Utilizing high-quality borescope cameras with high resolution and visual inspection techniques, we conducted a thorough assessment of the blades' condition. Following a repair plan recommended by the client's blade expert, our certified technicians utilized rope access techniques to repair the damages on the blade.

Our technicians possess a comprehensive foundation of knowledge and experience in similar projects - they hold internationally recognized certifications, including IRATA Rope Access, GWO Basic Safety Training (BST), and GWO Blade. This enabled us to extensively carry out complex repairs on damaged blades, successfully restoring them to full functionality within the stipulated time frame. By prioritizing safety in all aspects, we minimize risks, ensure project success, and keep wind farms running smoothly on time, which strictly follow wind industry standards. ■

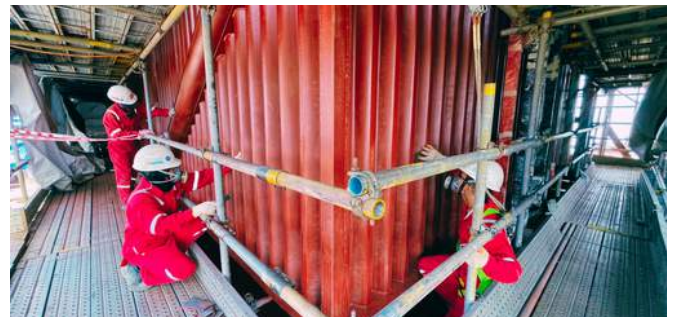
VIVABLAST is honored to perform PFP (Passive Fire Protection) application to protect drilling platforms in Southeast Vietnam. We brought our expertise in Passive Fire Protection to offer the most advanced painting system from recognized intumescent paint manufacturers. In the highly flammable environment of drilling platforms, we made sure to help the client meet the toughest fire safety rules.

Leveraging our team's qualification, extensive experience in PFP (Passive Fire Protection) projects and well-equipped with cutting-edge plural component equipment, Vivablast fostered close collaboration with clients to ensure project success. Thanks to our highly disciplined yet versatile workforce, we proudly met the required DFT and achieved the desired fireproof rating according to UL-1709. ■
